PRODUCT SUPPORT BULLETIN # 305

23-66-1666, 23-66-2121, 23-66-2145 SWITCH

SUBJECT: LEAD WIRE REMOVAL

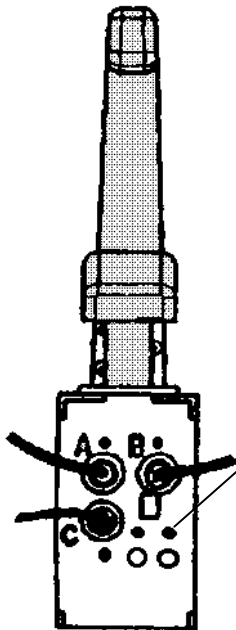
Switch Bottom

THERE ARE FIVE (5) HOLES IN THE BOTTOM OF THE 23-66-1666, 23-66-2121 & 23-66-2145 SWITCH TO RECEIVE LEAD WIRES.

NEXT TO THESE HOLE ARE 5 SMALLER HOLES THAT HAVE A BOTTOM OR THIN PLASTIC 'WINDOW' IN THEM

TO REMOVE THE LEAD WIRES FROM THE SWITCH, IT IS NECESSARY TO BREAK THROUGH THE THIN PLASTIC 'WINDOWS' OF THESE SMALL HOLES, TO ALLOW YOU TO INSERT A PROBE TO RELEASE THE WIRE(S).

AFTER REPLACING OR REINSERTING LEAD WIRES INTO THE SWITCH, THE SMALL 'WINDOW' HOLES THAT WERE BROKEN TO INSERT THE PROBE, MUST BE COVERED WITH 'RTV' SILICONE ADHESIVE/SEALANT (P/N 44-22-0070 - 2.8 FLUID OZ TUBE) TO PREVENT UNNECESSARY CONTAMINATION FROM REACHING THE INTERNAL COMPONENTS OF THE SWITCH AND EARLY SWITCH FAILURE.
