NVR vs. Conventional type - Component Comparison

Clutch Disc & Cover

2 AISIN Clutch Characteristics

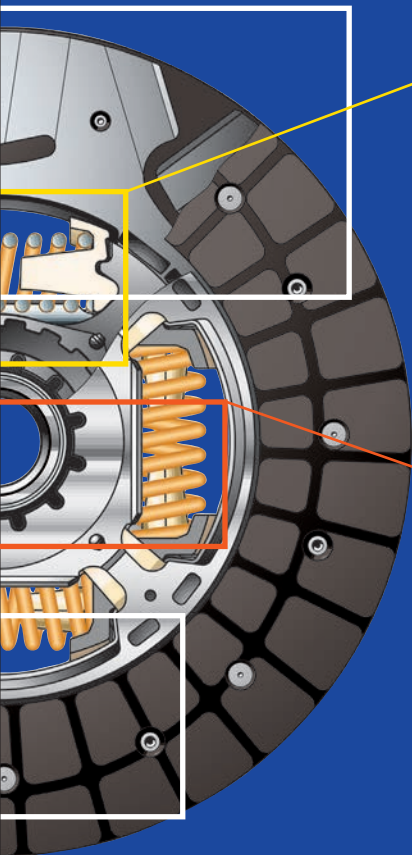
NVR

Addition of spring retainer to torsion seat

New coil spring design eliminates contact with the metal plate.

Use of large capacity coil springs

Large capacity coil springs enable expanded torque range.

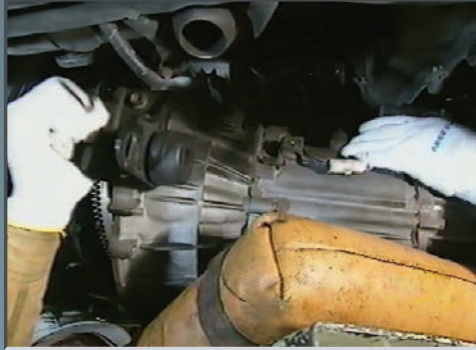
1 Use caution in the disassembly of the transmission and clutch components from the engine.

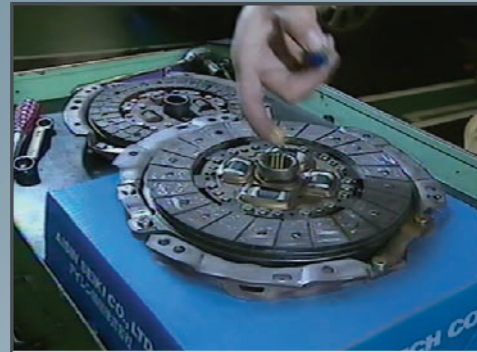
**3**

Apply appropriate amount of grease on the input shaft and disc spline.

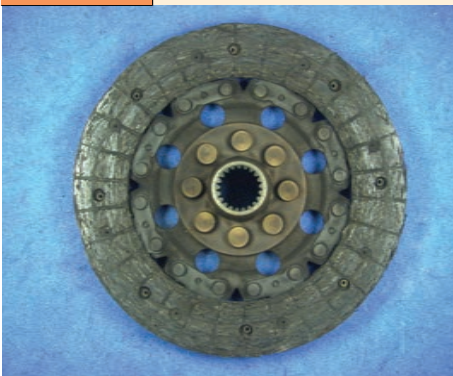
Condition: Facings are worn.

1. Facings have reached the end of its wear life.
2. Facings have been scorched due to excessive partial clutch engagement, excessive 2nd gear starts, or excessive downshifting, etc.
3. Improper driving method.

1. Improve driving method.
2. Replace disc and cover with new parts.

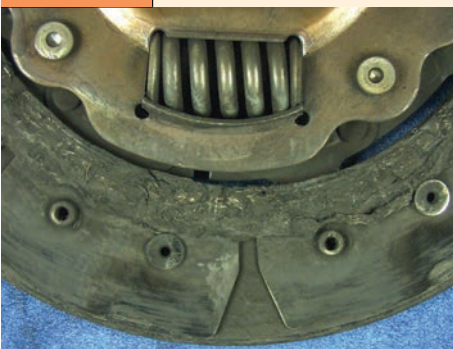
Condition: Facings have broken.

1. Facings have burst due to rapid change in torque (i.e.: mis-shifting or speed shifting).
2. Vehicle was driven with scorched facings.
3. Improper driving method.

1. Improve driving method.
2. Replace disc and cover with new parts.

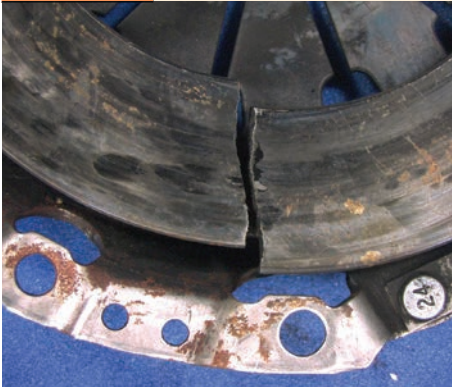
Condition: Pressure of the diaphragm spring is weak.

Disc Related Causes	Cover Related Causes	Other Causes
Cause:		<ol style="list-style-type: none"> 1. Spring function of the diaphragm spring has degraded due to heat fatigue. 2. Wrong part was installed. 3. Improper driving method. 	
Cure:		<ol style="list-style-type: none"> 1. Improve driving method. 2. Replace cover with correct part. 3. Replace disc and cover with new parts.

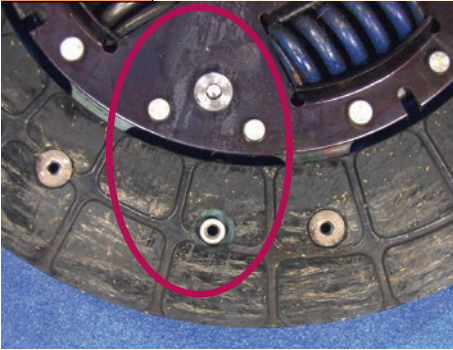
Condition: Oil or similar substance is on the friction surface of the facings.

1. Facing was touched with oily hands when replacing the part.
2. Excess spline grease was thrown onto the facing due to centrifugal force.
3. Improper installation.

1. Replace disc with new part.
2. Do not contaminate facing with oil.

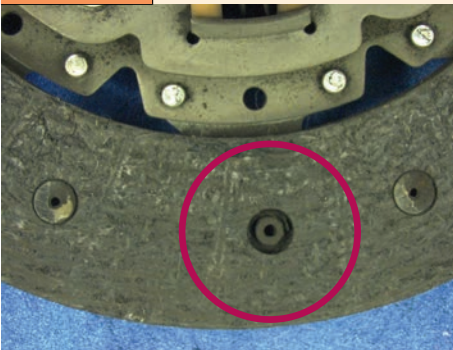
Condition: The friction surface of the facings is showing heat degradation.

1. Facing has reached the end of its wear life.
2. Facing has been scorched due to excessive partial clutch engagement, excessive 2nd gear starts, or excessive downshifting, etc.
3. Improper driving method.

1. Replace disc and cover with new parts.
2. Improve driving method.

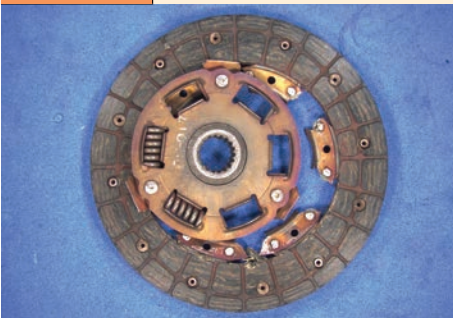
Condition: 2. Broken disc component.

Disc Related Causes	Cover Related Causes	Other Causes
Cause:	<ol style="list-style-type: none"> Misalignment caused disc to break and engine power is not being transmitted. Installation error. 		
Cure:	Replace disc and cover with new parts.

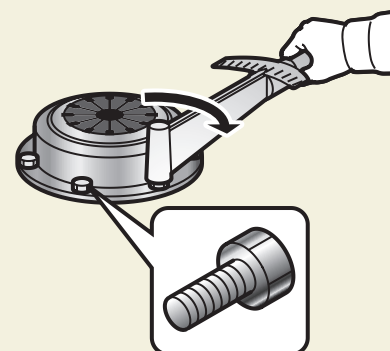
When tightening the cover, use bolts and torque specified from the vehicle manufacturer, using a torque wrench.

Bolts can break if the vehicle manufacturer's specified bolts are not used or not tightened to torque specifications.
