## SERVICE PARTS LIST

SPECIFY CATALO	G NO. AND SERIA	REVISED BULLETIN	DATE		
	54-40-1626	Sept. 2017			
CATALOG NO.	6370-20	SERIAL NUMBER	A35C	WIRING INSTR 58-01-0

METAL CUTTING SAW

STARTING SERIAL NUMBER A35C and A35D CATALOG NO. 6370-20

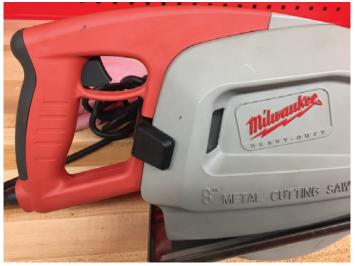
## Serial 'C' Construction-

If the tool you are servicing looks like this, continue to use this Bulletin, No. 54-40-1627

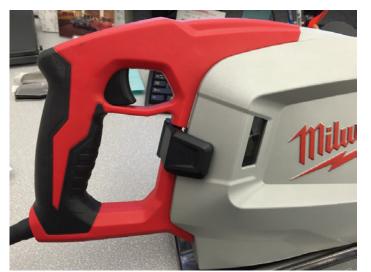
**Serial 'D' Construction-**If the tool you are servicing looks like this, use Bulletin No. 54-40-1628

A35<u>C</u>D1252XXXXXX thru A35<u>C</u>D1528XXXXXX or A35DDXXXXXXXXXX

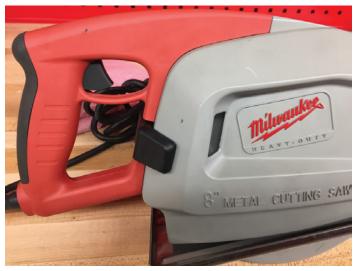
Serial 'C' Construction-If the tool you are servicing looks like this, use Bulletin No. 54-40-1627

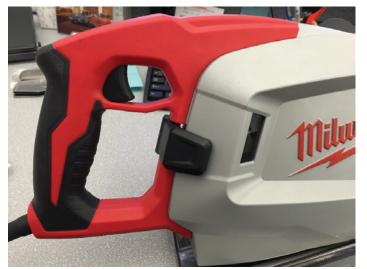
Serial 'D' Construction-If the tool you are servicing looks like this, continue to use this Bulletin. No. 54-40-1628

A35CD1252XXXXXX thru A35CD1528XXXXXX or A35DDXXXXXXXXXXX

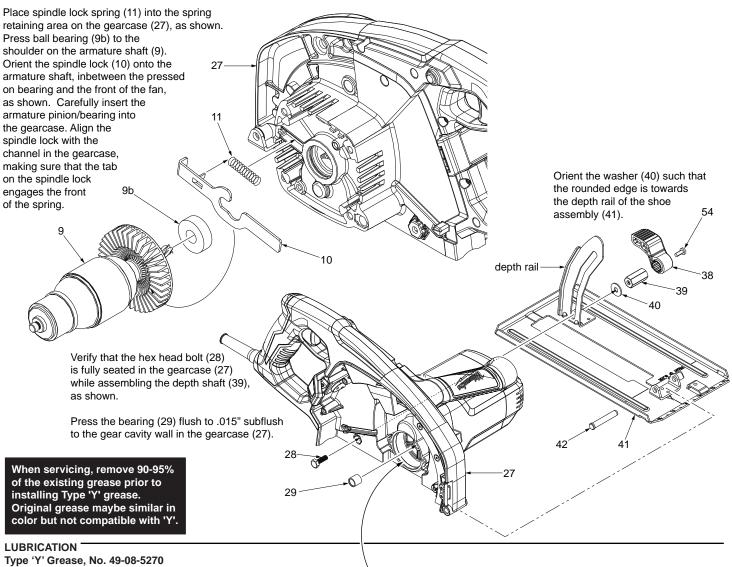
Note: Approx. 20 grams (.7 oz.) will be used

- Place a light coat of grease on the lower guard shaft (17) before assembling into the geacase hole. (Approx. 1g/.035oz.).
- Coat o-ring (12) with grease prior to installing in groove of bearing cavity of gearcase (27). Coat bearing cavity (with o-ring installed) with grease prior to installing ball bearing (9b). (Approx. 2g/.07oz.).
- Place a heavy coating of grease over and around all teeth of the pinion gearing of the armature (9). (Approx. 2g/.07oz.).

Place 9-11 grams (.32-.39oz.) of grease into the gear cavity of gearcase (27) prior to installing the service hub assembly (44).

- Place a heavy coating of grease over and around all of the teeth of the gear of the servive hub assembly. (Approx. 3g/.1oz.).
- Coat the outside surface of needle bearing (29) and the needle bearing cavity of gearcase (27) with grease. (Approx. 1g/.035oz.)

Parallel 15 16 Orient the textured gripping surface of the lower guard lever (16) so it is parallel (±20°) with the back edge of the front handle (15), as shown. 6 Functionally check the lower guard (47), with the saw set at full depth of cut. Place the saw upside down with the shoe (41) horizontal. Retract the lower guard 100%. 0 Release the lower guard lever (16). The guard should return in a brisk manner. ۲ Parallel 41 38 When tight, the depth adjustment lever (38) should be parallel (±20°) 47 with the shoe (41).
