AIR OPERATED CHASSIS PUMP

**50:1 RATIO, OUTPUT – 80 CU. IN./MIN.
MIN. AIR PRESSURE – 30 PSI
MAX. AIR PRESSURE – 150 PSI
MAX. OUTPUT PRESSURE – 7500 PSI
*RECOMMENDED OPERATING PRESSURE 80-100 PSI***

OWNERS MANUAL

MODEL ATD5219-1

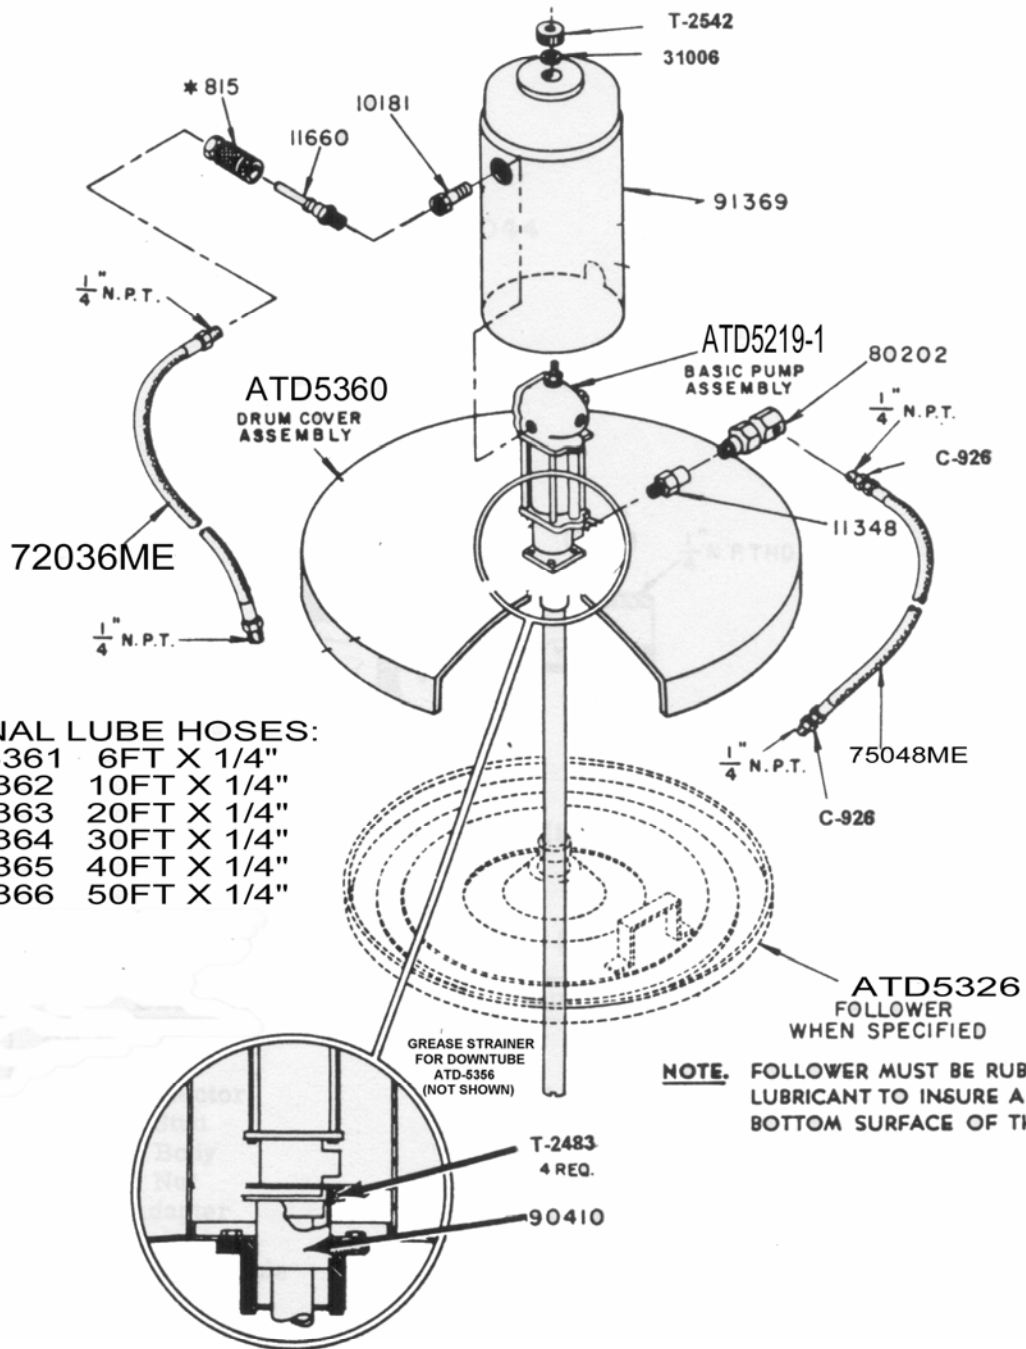
ATD-5219 400LB DRUM PUMP ASSEMBLY DIAGRAM

ATD5219

CHASSIS LUBRIGUN

400 LB. DRUM SIZE 50:1 RATIO

NOTE. FOLLOWER MUST BE RUBBED INTO THE LUBRICANT TO INSURE A SEAL ON THE BOTTOM SURFACE OF THE FOLLOWER.

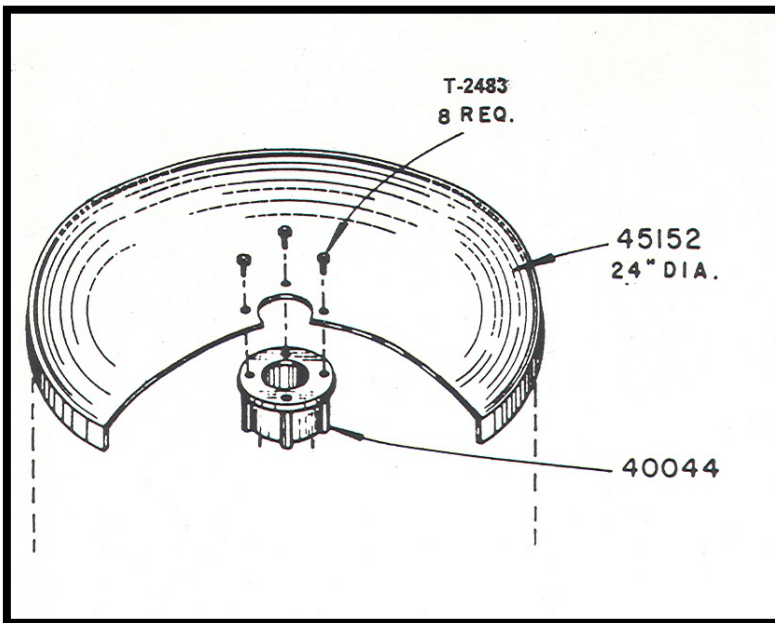
Drum Cover Assembly

Locate ATD-5360 Drum Cover Assembly on Lubricant Drum.

Insert Pump Tube through Hole in ATD-5360 Drum Cover Assembly until Pumping unit is resting securely on Drum Cover.

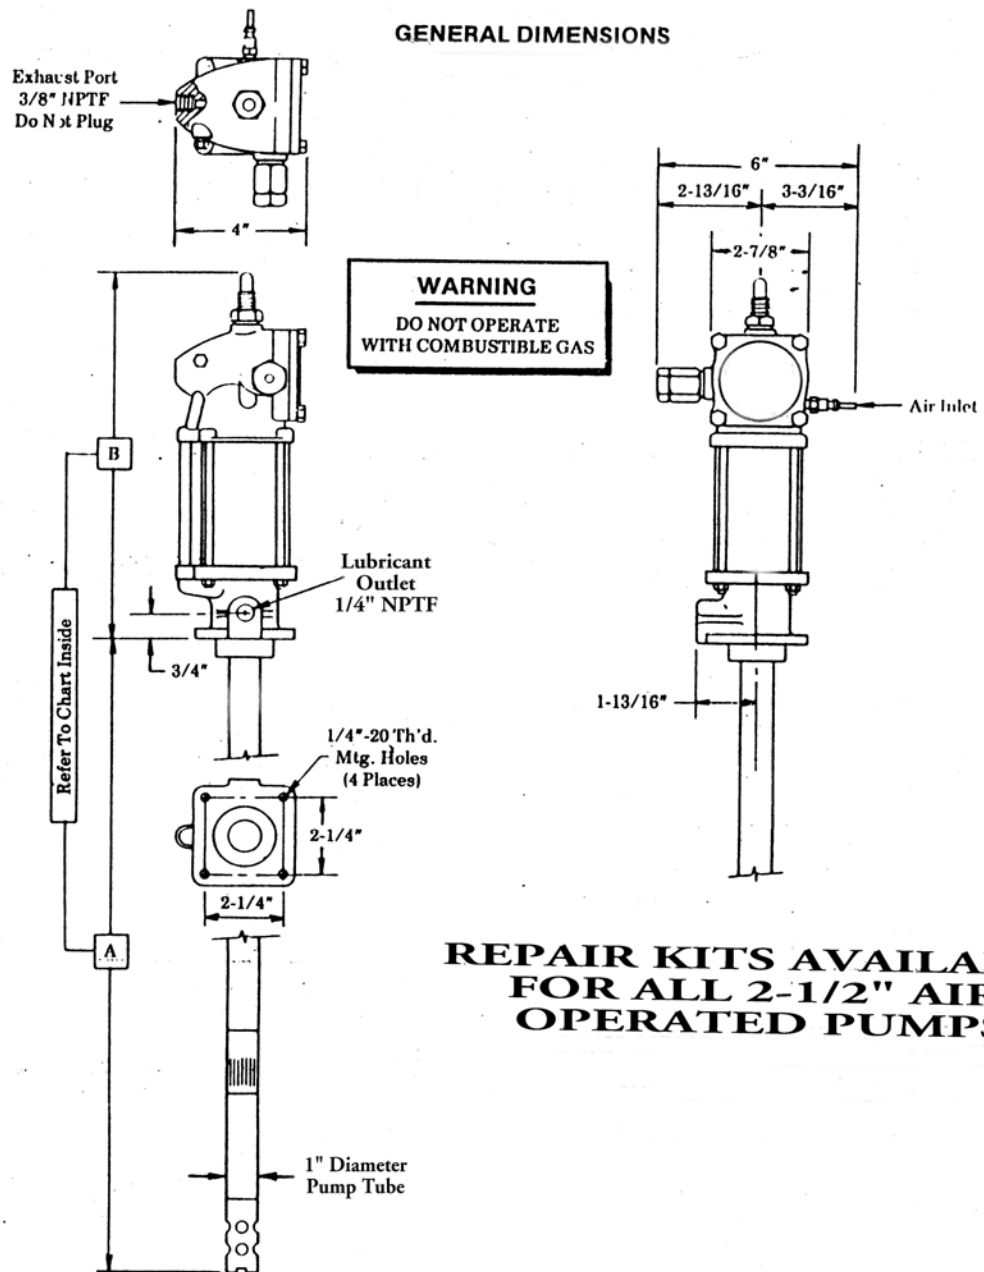
2-1/2" AIR MOTOR OPERATED PUMPS

(CHASSIS - 50:1 RATIO)

Dim "A" = 33-15/16"; Dim "B" = 11"

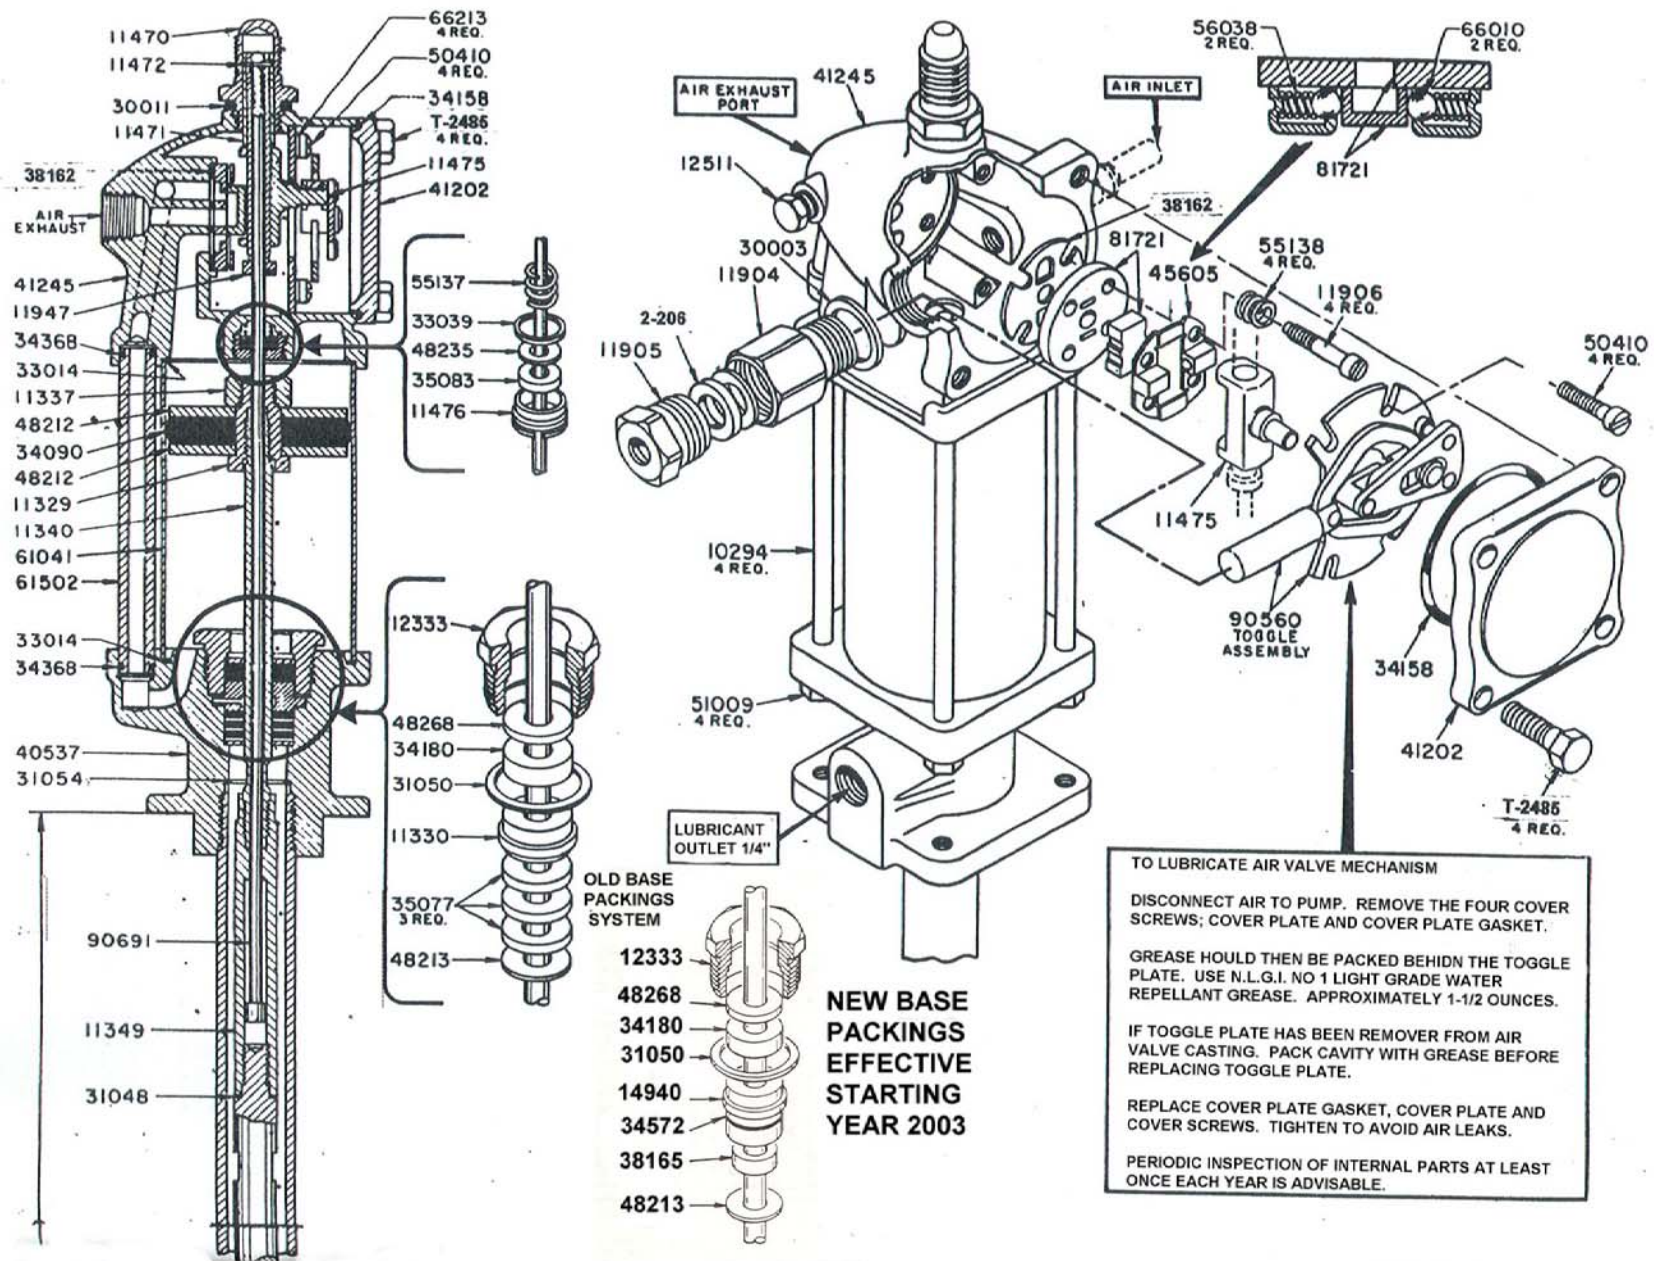
TO LUBRICATE AIR VALVE MECHANISM

DISCONNECT AIR TO PUMP. REMOVE THE FOUR COVER SCREWS; COVER PLATE AND COVER PLATE GASKET.

GREASE HOULD THEN BE PACKED BEHIND THE TOGGLE PLATE. USE N.L.G.I. NO 1 LIGHT GRADE WATER REPELLANT GREASE. APPROXIMATELY 1-1/2 OUNCES.

IF TOGGLE PLATE HAS BEEN REMOVER FROM AIR VALVE CASTING. PACK CAVITY WITH GREASE BEFORE REPLACING TOGGLE PLATE.

REPLACE COVER PLATE GASKET, COVER PLATE AND COVER SCREWS. TIGHTEN TO AVOID AIR LEAKS.

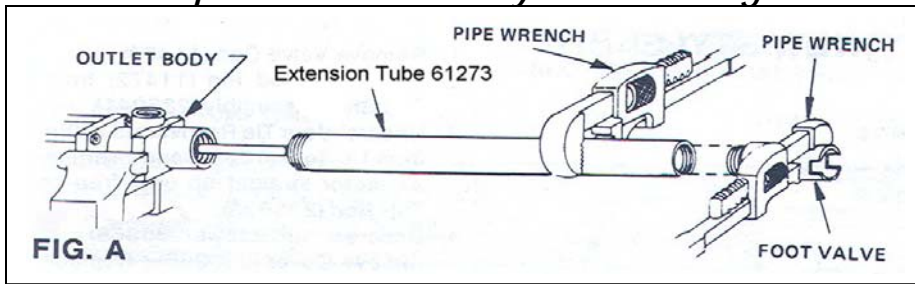
FIG. A

FIG A. (See Fig. A) Lay pump horizontal in vise and grip outlet body tightly in vise jaws. Hold Extension Tube (61273) and unscrew Priming Tube (61275).

Take off the Foot Valve 61275.

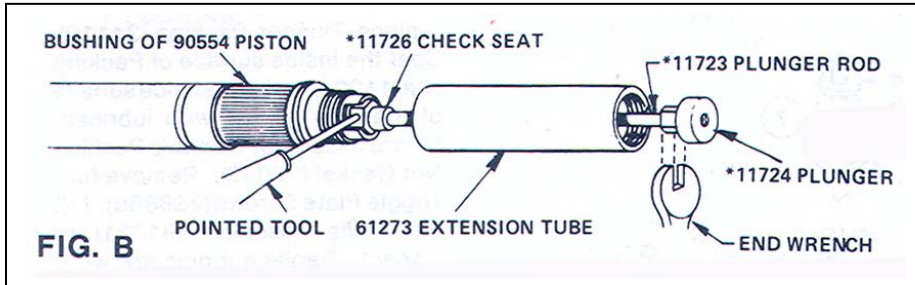
FIG. B

FIG B. (See Fig. B) Pull Plunger (11724) straight out until Plunger Rod (11723) is extended as far as possible out of the Extension Tube (61273). Hold bushing of Piston (90554) and unscrew Extension Tube (61273).

Center Extension Tube (61273) between end of piston bushing and Plunger (11724). Insert any pointed tool in through hole at Base of Check Seat 11726.

Note: Plunger may unscrew from Plunger Rod (11723) or plunger rod may unscrew from Check Seat (11726). Extension Tube (61273) can be removed from free end of Plunger Rod (11723).

#2: Unscrew the extension tube 61273; Do not Yank it out. You will need a pipe wrench to unthread the extension tube; actually two; one on the bushing and plunger assembly piece (90554ME) to hold it steady and the other on the extension tube to unthread the extension tube off of the end of the Bushing and Plunger Assembly.

Stick the pointed tool (usually a punch of the correct diameter) in the check seat hole of 11726 and use an adjustable wrench on the plunger. .

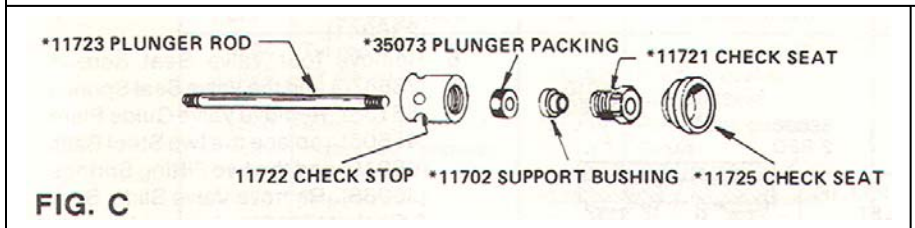
FIG. C

FIG C: (See Fig. C) When you remove the Extension Tube (61273) this exposes the Check Seat (11725), Priming Check (11721), Check Stop (11722), Support Bushing (11702) and Plunger Packing (35073).

Note: Unscrew Priming Check Seat (11721) from Check Stop (11722) to remove Support Bushing (11702) and Plunger Packing (35073); To do this you will have to put Check Seat (11721) in a vise and insert a point tool such as a punch through the holes in Check Stop (11722) to unthread Check Stop (11722) from Check Seat (11721).

Plunger Packing (35073) incurs heavy wear and it is advisable to replace this part if worn.

Once the plunger is off of the plunger rod (it is unthreaded) you can slide the complete unit off. Sometimes the rod 11723 unthreads from the the check seat 11726, that is fine as well. If there are dirt, rocks, metal or plastic in that area, clean it out. While you have it off, replace the plunger packing 35073. We offer Buna N (black), Viton(Brown) and Teflon(White). It is a wear part.

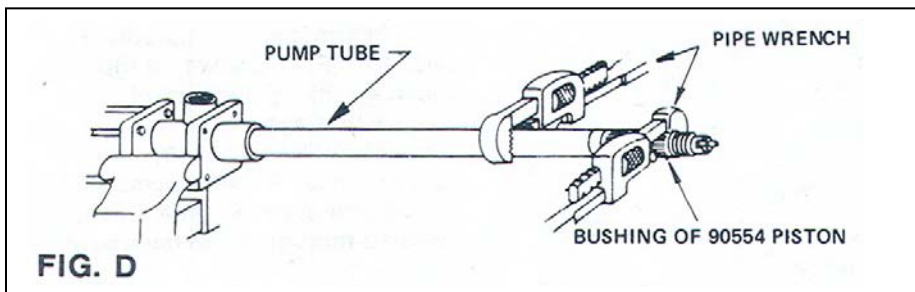
FIG. D

FIG D. (See Fig. D) Removing Bushing and Plunger Assembly (90554ME); Hold pump tube and unscrew bushing of Piston (90554). Bushing should slide off once unthreaded from the Pump Tube.

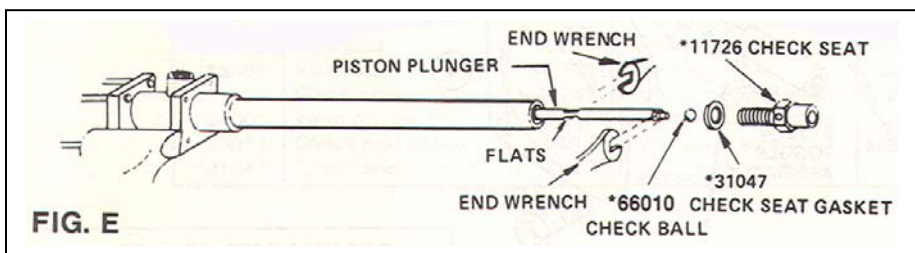
FIG. E

FIG E. Grip two flats at top of piston plunger with an end wrench and remove Check Seat (11726).

Note #1: Check Ball (66010) may remain in plunger after Check Seat (11726) is removed. To remove check ball tilt pump in vise and gently tap top of plunger at location of two flats.

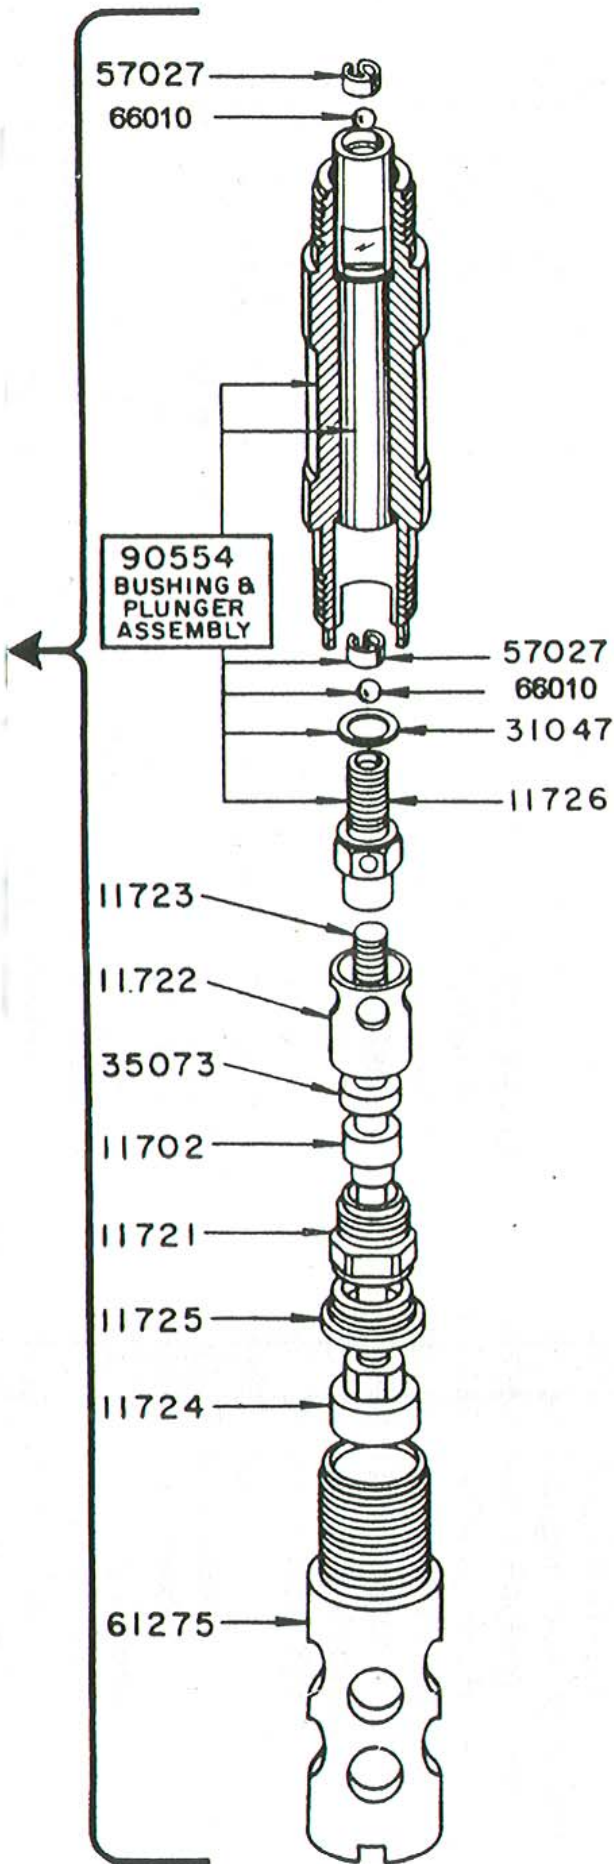
Note #2: You only remove that check ball (66010) if you suspect foreign material is behind the check ball. You can perform a visual inspection after the check ball is removed and if there is foreign debris behind the check ball, then continue and remove the bushing and plunger assembly as well. (See below).

Occasionally debris such as **paper, bubble gum, plastic, cellophane, plastic bags etc.** have gotten wedged up inside the plunger portion of the bushing and plunger assembly. Flats are provided on the plunger portion to remove the complete plunger and inspect the inside.

This removal will also facilitate the easy extraction of the ball cage 57027 and ball 66010 at either end of the plunger. Be sure to note the order of installation of the plunger assembly on the pump rod (ie which is the top and which is the bottom). Don't confuse the two. If you reverse the plunger, the pump will not work correctly. **Again, don't confuse the top and bottom of the plunger.** Once you remove the two (2) ball cages 57027 and the 2 balls 66010, you should be able to look directly through a clean orifice inside the plunger assembly. If not, then something is blocking the inside of the plunger assembly and it must be removed. Do not scratch the machined surfaces of the plunger or the inside of the bushing. Normally the item in the plunger is of a nature similar to the materials mentioned above in bold. This is not a common occurrence to have material stuck or wedged in the plunger assembly but it has happened.

When reassembling the plunger assembly, **NOTE #1:** The top and bottom of the plunger assembly. You were careful in the beginning and noted it when you took it apart. **NOTE #2:** notice the order of the ball and cage. Starting from the bottom, it is ball; cage; then at the top of the plunger it is cage; ball; If you reverse this order, the pump will not operate at all.

The gasket ring 31047 and 11726 is inserted onto the bottom of the plunger. Use the milled flats to tighten 11726. Assemble the balance of the items in reverse order to disassembly. Note the drawing to the left. When reinstalling the bushing extension 61273(not shown), install the unit over the other interior parts and let it hang loose. Thread the rod 11723 onto the bottom of 11726. To tighten the rod, you will have to insert a small punch into the hole of 11726. See Fig B on page 1. We are now tightening the rod 11723 by putting a wrench on the plunger 11724. Assemble balance of items as shown.
