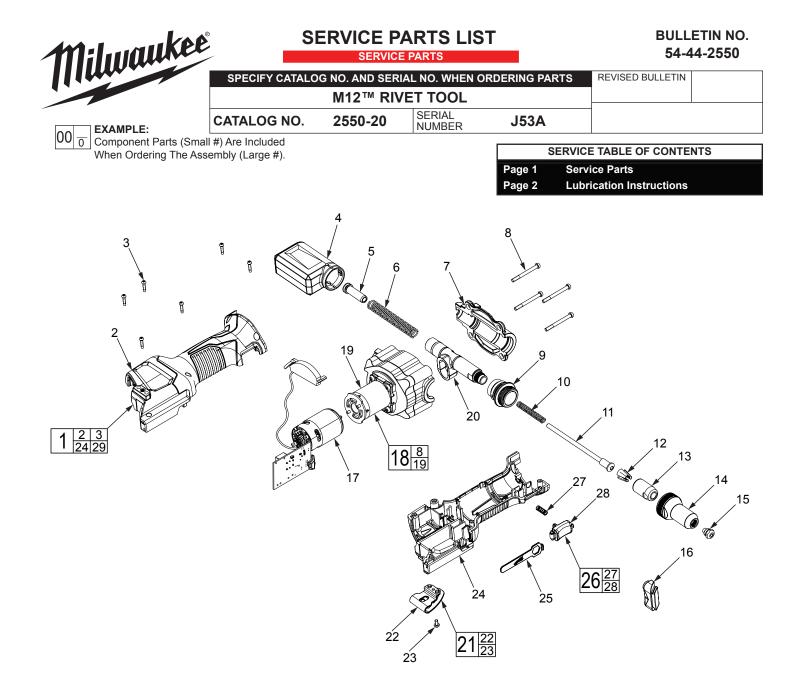
FIG.	PART NO.	DESCRIPTION OF PART	NO. REQ.	FIG.	PART NO.	DESCRIPTION OF PART	NO. REQ.
1	14-38-2550	Housing Kit	(1)	15e	48-54-0100	Retention Nose Piece Kit	
2		Right Housing	(1)			(Includes: 3/32", 1/8", 5/32" and 3/16"	
3		M3 Screw	(6)			Retention Nose Pieces)	(1)
4	43-72-2560	Mandrel Collector Assembly	(1)	16	43-72-2550	Nose Pieces Holder	(1)
5	45-76-2550	Mandrel Exit Tube	(1)	17	14-30-2550	Motor & Electronics Assembly	(1)
6	40-50-2550	Yoke Spring	(1)	18	14-30-2555	Gear Case Assembly	(1)
7	31-15-2550	Top Housing	(1)	19		Gear Case	(1)
8	05-81-2550	M4 x 0.7 Screw	(4)	20	45-98-0500	Yoke Assembly	(1)
9	45-22-2550	Sleeve	(1)	21	43-72-2555	Belt Clip Kit	(1)
10	40-50-2555	Jaw Pusher Spring	(1)	22		Belt Clip	(1)
11	44-60-2550	Pusher Tube Assembly	(1)	23		Screw	(1)
12	30-55-0035	Machine Jaws Kit (Set of 3)	(1)	24		Left Housing	(1)
13	43-56-2550	Guide	(1)	25	45-96-0500	Wrench	(1)
14	43-56-2555	Nose Housing	(1)	26	45-72-0205	Trigger Kit	(1)

15a	48-98-0005	3/32" Non-Retention Nose Piece	(1)	27		Trigger Spring	(1)
15b	48-98-0010	1/8" Non-Retention Nose Piece	(1)	28		Trigger	(1)
15c	48-98-0015	5/32" Non-Retention Nose Piece	(1)	29	12-20-2551	Service Nameplate (Not Shown)	(1)
15d	48-98-0020	3/16" Non-Retention Nose Piece	(1)	30	10-20-2551	Warning Label (Not Shown)	(1)

Clean and lubricate the nose of the tool after heavy use (5000 rivets) or if tool becomes contaminated with dust and debris.

1. Remove battery pack.

- 2. Remove the nose housing from the tool and the nose piece from the housing.
- 3. Remove the guide (with jaws), pusher tube, and spring from the tool.
- Clean all pieces with a dry cloth and inspect for damage. If damaged, return to a MILWAUKEE service facility for repairs.
- 5. Apply a small amount of 51-08-4290 grease to the pieces and reassemble, as shown. Ensure the jaws are properly seated in the guide.
